Reserve Fund Study

My Condominium

Plan 012 3456

Number of Units	36
Number of Buildings	1
Building Construction	2001
Contact	Ima Happy
Position(s)	President
Contact Phone	403.555.4321
Report Date	August 8, 2006
Reserve Fund Study Prepared by	M3 Consulting

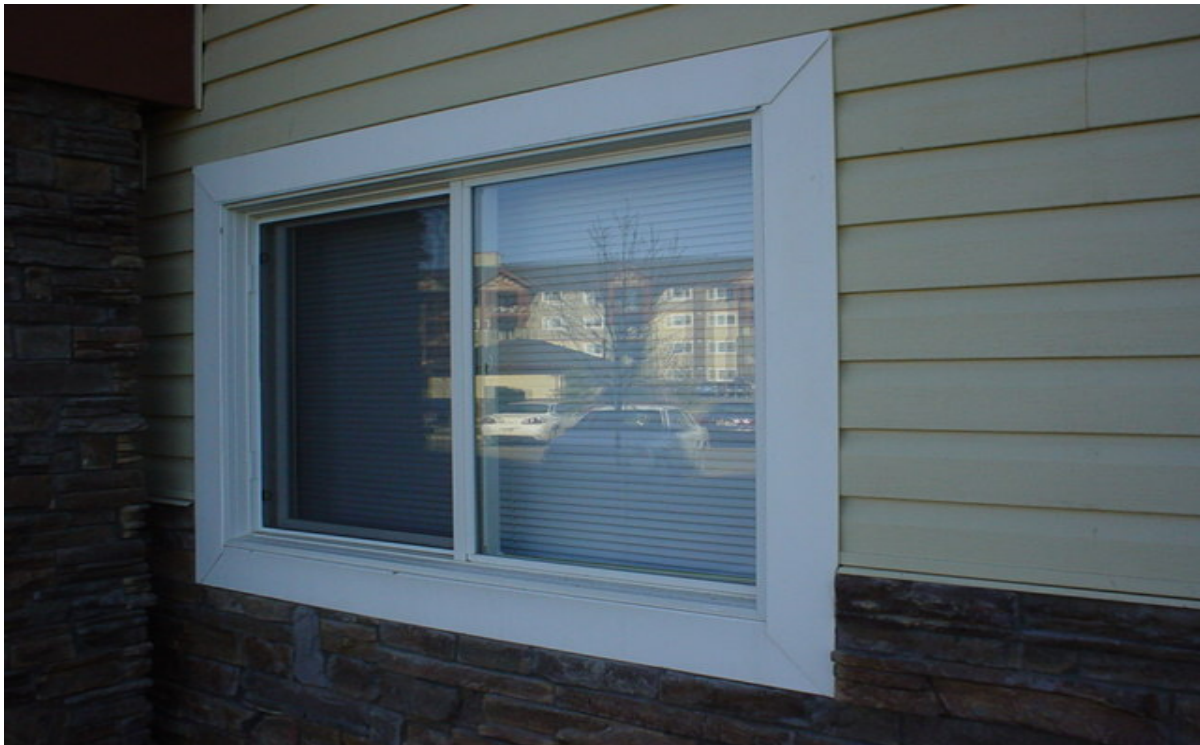
Window Assemblies

Measurements for this item came to approximately 9272 sq/ft. The building has original slider and fixed windows. All windows in good condition with no fogging or freeze up noted at time of survey. Checked for cracked, broken, or missing panes but none noticed. No windows painted shut. Panes from sliders properly secured with no latches broken at time of survey. Checked the condition of the window frames and sashes in one unit and was found to be in good condition for windows inspected. Inspected screens for torn sections and holes and no occurrences noticed. At time of inspection, windows not tested for ease of operation. No rotting or corroded sections noticed with this item.

As the need for replacing of windows can come from faulty windows, poor installation of the windows themselves and weather conditions (cold, rain, sunlight, dust, etc.), the lifespan of these windows are difficult to determine. Prefinished vinyl/aluminum clad windows generally have a lifespan of approximately 20 years. The conditions of the windows should be checked by the maintenance person(s) and amounts might need to be allocated sooner if the windows are not able to meet their normal lifespan. At time of survey, no builder details were available in either a sales binder outline, Condominium financial information or architectural plans indicating if repairs and replacements to this item have occurred. No warranties or guarantees will be assumed for this item.

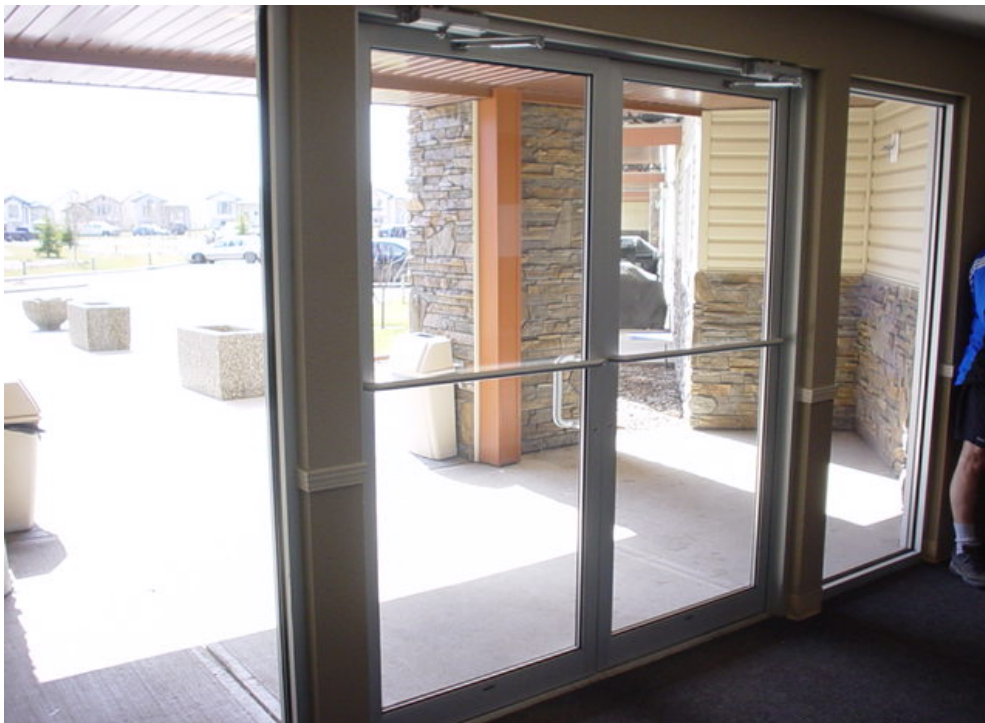
Door Assemblies

A component price for this item will be given and it includes the replacement and repairs of 1 glass patio door and 1 single passage per unit as well as passage door into the boiler/electrical room, glass main doors leading into the building and passage doors leading into the stairwells. The overhead garage doors for building 2 are also considered in this section. Realistically, the component that will require the most attention under this category will likely be the garage doors and the main passage doors into the buildings. As this building has high owner occupancy, breaking of main entrance doors due to “moving in and out” of tenants is unlikely.

Doors leading into buildings and units tend to require more maintenance than full replacement. Doors should also be considered part of annual maintenance rather than exclusively a scheduled item for full replacement. Time frames given for this item are budgetary suggestions but this item should be repaired and replaced as required. Exterior doors checked for cracked, chipped, broken sections but no occurrences noted.
